# Collecting data to define future hazard scenarios of the Tessina landslide

Franco Mantovani<sup>1</sup>, Alessandro Pasuto<sup>2</sup>, S. Silvano<sup>2</sup> and A. Zannoni<sup>2</sup>

Research has been carried out within the framework of the RUNOUT project to define future hazard scenarios of the Tessina Landslide and to determine whether the slide can be related to hydrogeological factors or deep tectonic structures/discontinuities. The work consisted mainly of mapping the geology and geomorphology, collecting meteorological, hydrological and kinematic data, and data modelling. We describe the monitoring system installed on the Tessina landslide and the analyses of data acquired since the start of RUNOUT, a project funded by the EC. Our main goal was to support the group doing the modelling by providing measurements of the principal parameters, such as displacements, groundwater level variations, rainfall, etc., for improving the models used to simulate the behaviour of the landslide and forecast the risk scenarios for the villages. We discuss the critical phase of September-October 1998 and propose a possible future geomorphological evolution of the landslide based on analy

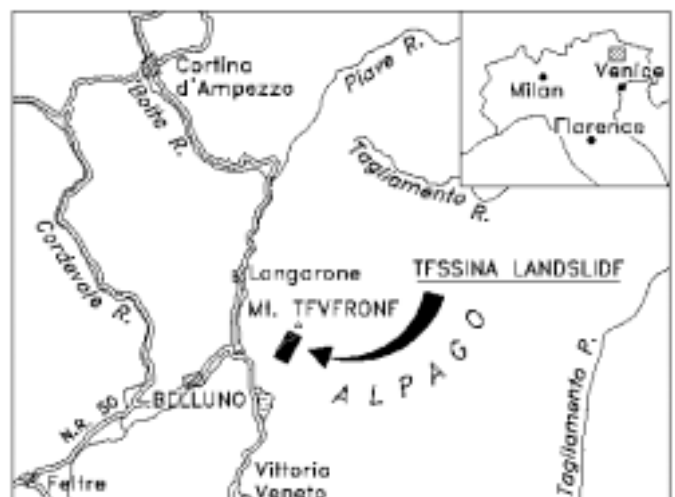
**FIGURE 1** Location of the Tessina landslide.

The Tessina landslide is located on the south slope of Mt. Teverone, in the eastern part of the Alpe valley in the Province of Belluno (Northeastern Italy, Figure 1). It was triggered on 30 October 1960 by a rotational slide involving some 1 million m<sup>3</sup> of material following intense rainfall (398.7 mm in the month of October alone). In the following four years, three reactivations took place, always after considerable precipitation and affecting the same volume of material; they led to the formation of a flow which eventually came to a standstill at 600 m from the village of Lamosano (Figure 2). In 1966, although all the Belluno region was struck by disastrous flooding, the landslide did not show any significant reactivation and up to 1987 its activity was extremely low.

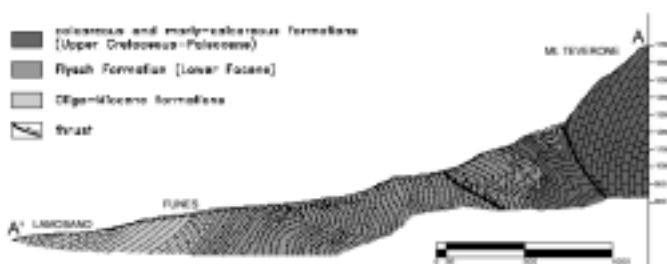
**FIGURE 3** Geological cross section of the Tessina landslide (see Figure 2).

From the geological viewpoint, the slope area affected by the landslide belongs to the northern flank of the asymmetrical brachy-syncline of the Alpago catchment basin; this structure, which developed in Tertiary formations, has an axis showing a slightly curved trend [Mantovani *et al.*, 1976]. In its northernmost part, this syncline is also affected by some important NNW-SSE orientated tectonic alignments. In the Alpago valley there are outcrops of formations of a chronostratigraphic sequence spanning the Jurassic to the Quaternary. Only the Mesozoic and pre-Oligocene Cainozoic formations are important as far as the Tessina landslide is concerned, whereas subsequent formations (*ie.* from Oligocene and Miocene) are only marginally affected by the flow's lowermost portion. The calcareous, marly-calcareous and cherty-calcareous formations (Upper Cretaceous-Palaeocene), are mainly organised in layers of variable thickness and are permeable due to fissuring.

The material involved in the slope movement belongs to the Flysch dell'Alpago (Lower Eocene). It is made up of a rhythmic alternation of marlstones, clay shales and calcarenitic layers up to 1 m thick. The overall thickness of the formation ranges between 1000 and 1200 m; it makes up the substratum of the whole landslide area. This formation is particularly permeable due to a high degree of fissuring mainly resulting from tectonic stresses. It dips generally upstream, with overturned strata corresponding to the main scarp and the upper part of the landslide. Further downhill, it dips south, downstream at a low angle (Figure 3). The Quaternary deposits are Pleistocene and Holocene in age and from the foot of the Mt. Teverone slopes there are regular outcrops of variable thicknesses covering the underlying formations. Apart from vast, detritic covers found at the foot of Mt. Teverone, moraines from the Piave glacier and local glaciers are also present. The latter, in the form of glacis, are seen on both sides of the valley.
