Geomorphological Hazard Map

Borsoia river catchment, Alpage, Regione del Veneto, Italy

Scale 1: 10,000

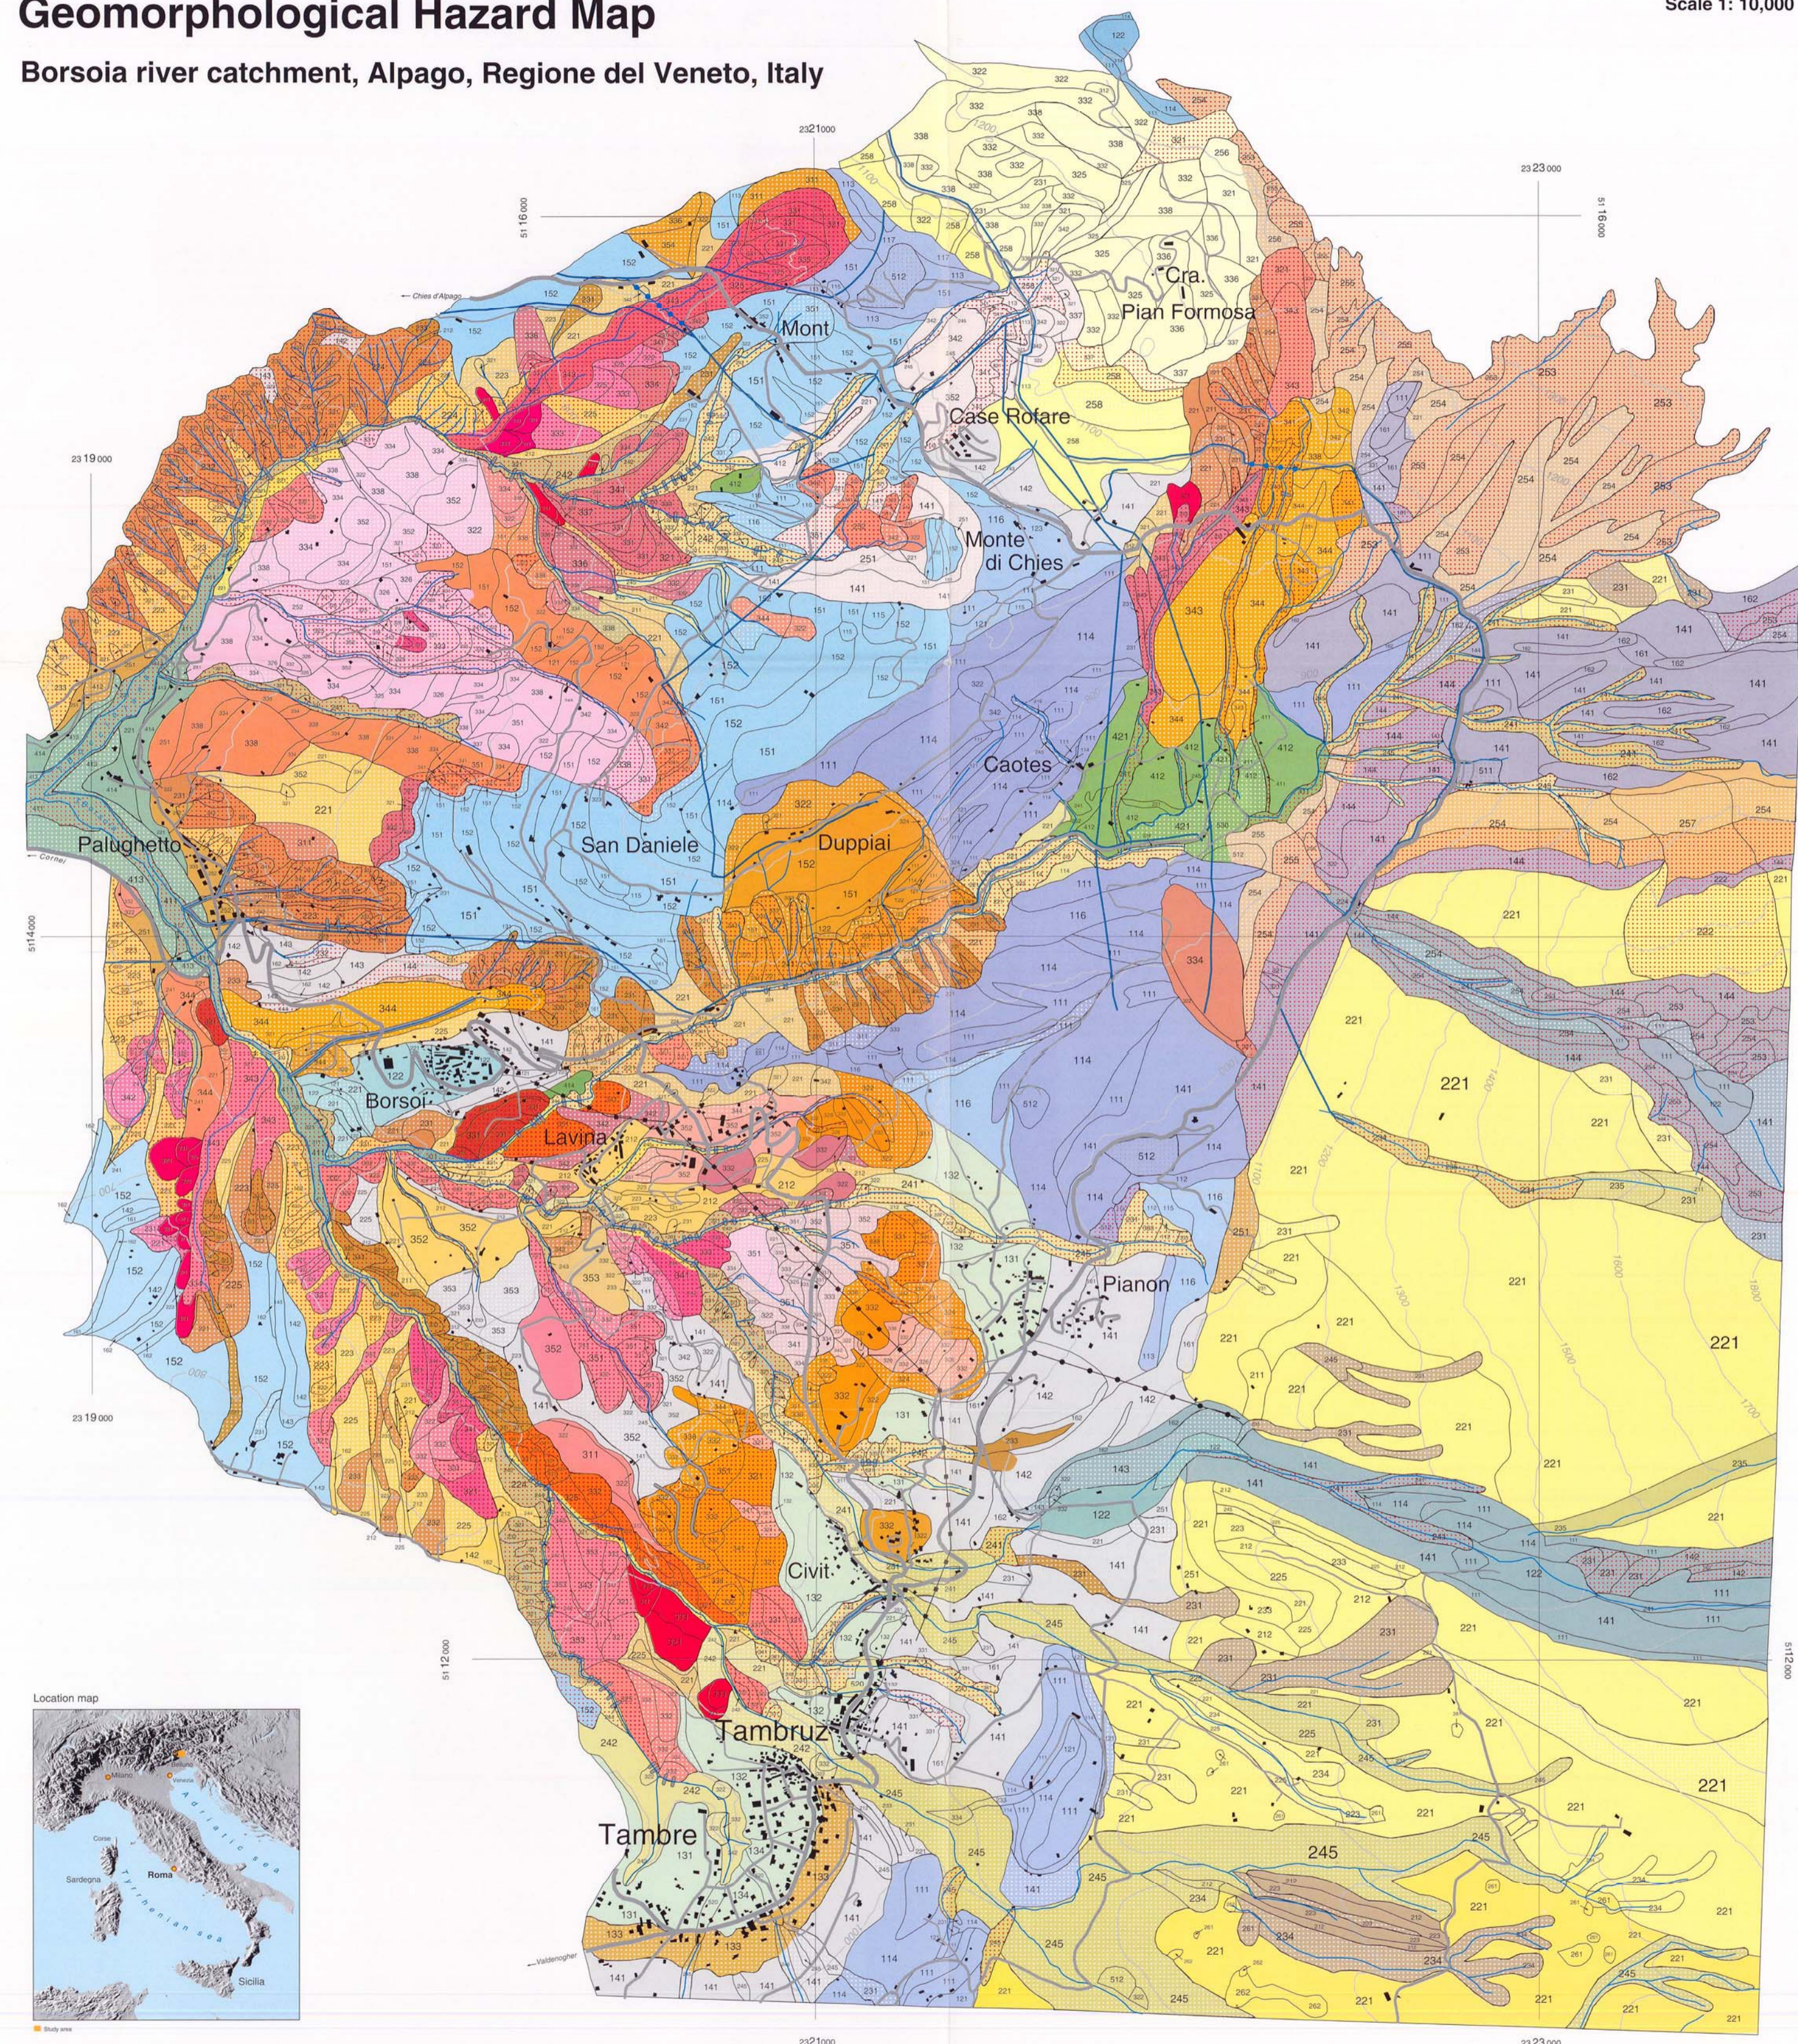
Hazard classification

- Low hazard:** In these areas no destructive phenomena (landslides, rockfall, mudflows) are expected to occur within the coming decade, given that the landslide situation remains the same. Inadequate construction of infrastructure or buildings may lead to problems, however!

- Moderate hazard:** In these areas there is a moderate probability that destructive phenomena will occur that may damage existing infrastructure or buildings. However, the damage is expected to be localized and can be prevented or avoided by relatively simple stabilization measures.

- High hazard:** In these areas there is a high probability that destructive phenomena will occur. These are expected to damage infrastructure or buildings considerably. It is advised not to construct new infrastructure or buildings, or at least only after detailed study.

- Quarries:** The hazard degree is related to quarrying activities.
